**NASA TECHNICAL
MEMORANDUM**

REPORT NO. 53882

TITANIUM 8Al-Mo-IV CROSS BEAM REPAIR

*George C. Marshall Space Flight Center
Marshall Space Flight Center, Alabama*

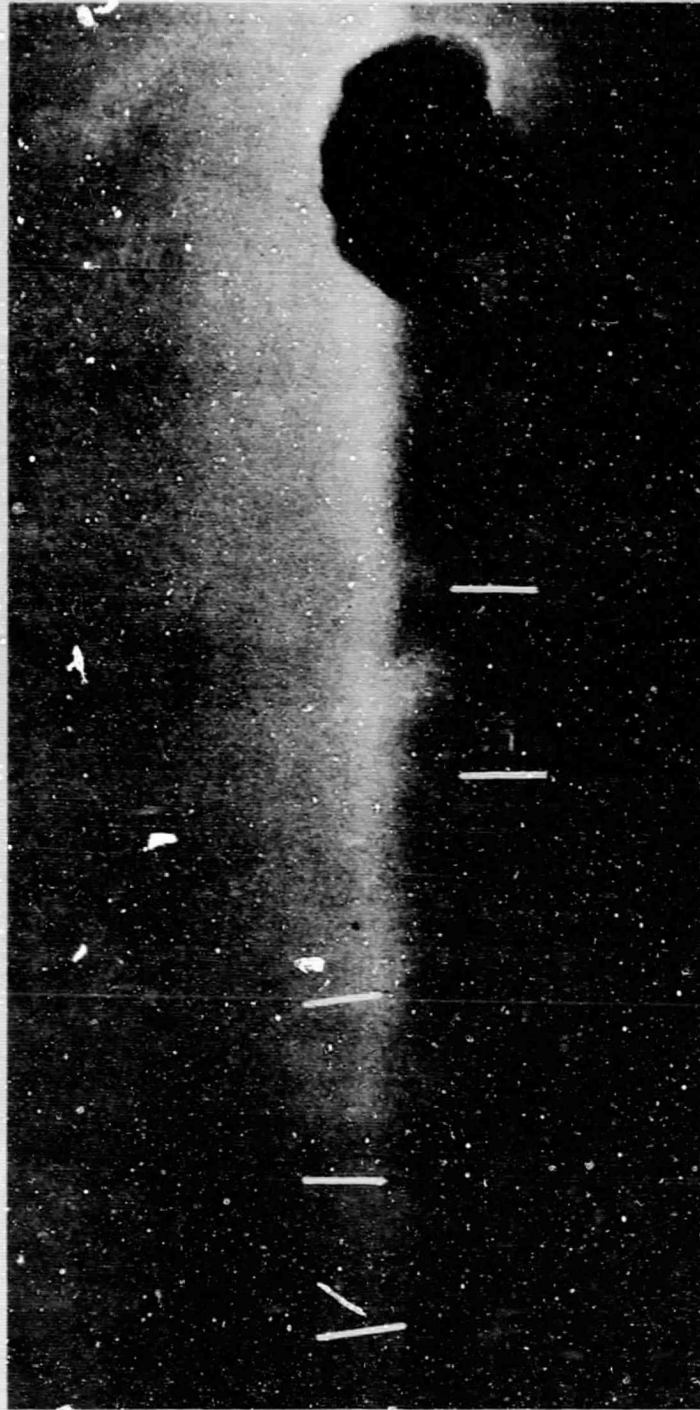
Microstructural analysis of the cracks in the vertical seams and burn-through welds indicates that the defects propagated from tungsten impurities or porosity in the welds, as shown in Figures 2 and 3.

FIGURE 2. VERTICAL SEAM WELD WITH LARGE AMOUNT OF
RESIDUAL TUNGSTEN IMPURITY DEPOSITED FROM THE
WELDING ELECTRODE

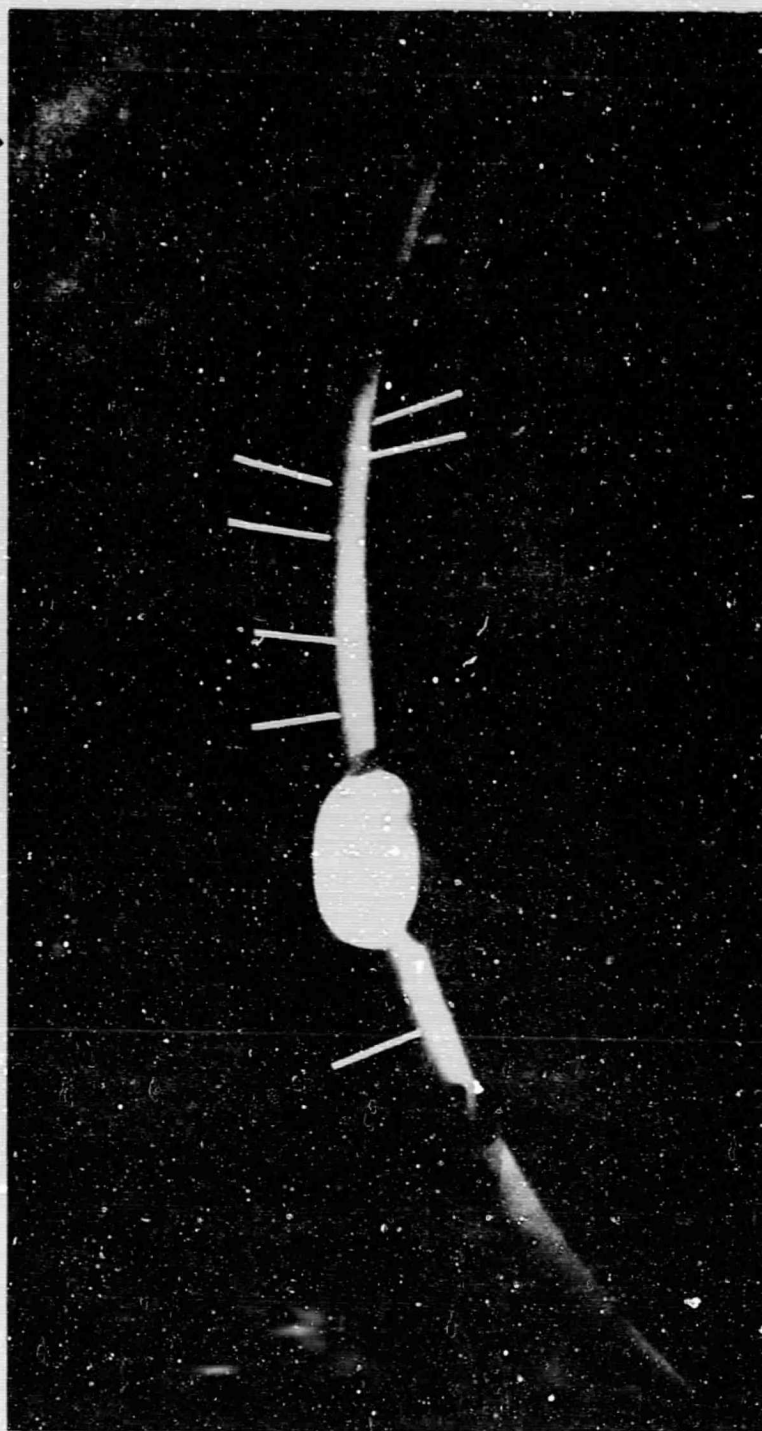
FIGURE 3. INCLUSIONS ON THE BOTTOM BURN-THROUGH WELD.
NOTE THE TAILS EXTENDING FROM SEVERAL OF THE PORES

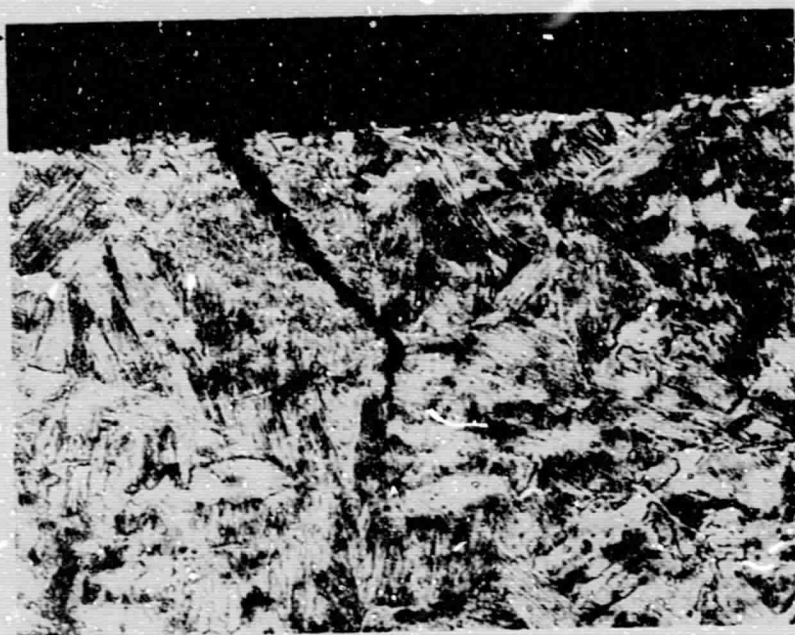
Cracks around the insert cylinders are attributed to a form of embrittlement. An α phase is observed in Figure 4 on the surface of the titanium removed from the crossbeam. The bright phase along the surface is the α phase. The presence of this phase indicates that embrittlement resulted from an influx of impurities into the titanium. The major crack shown in Figure 5 is surrounded by smaller microcracks. This type of fracture, characteristic of brittle materials, was evidently caused from a loss of ductility in the titanium.

FIGURE 4. PHOTOMICROGRAPH OF α PHASE ALONG SURFACE

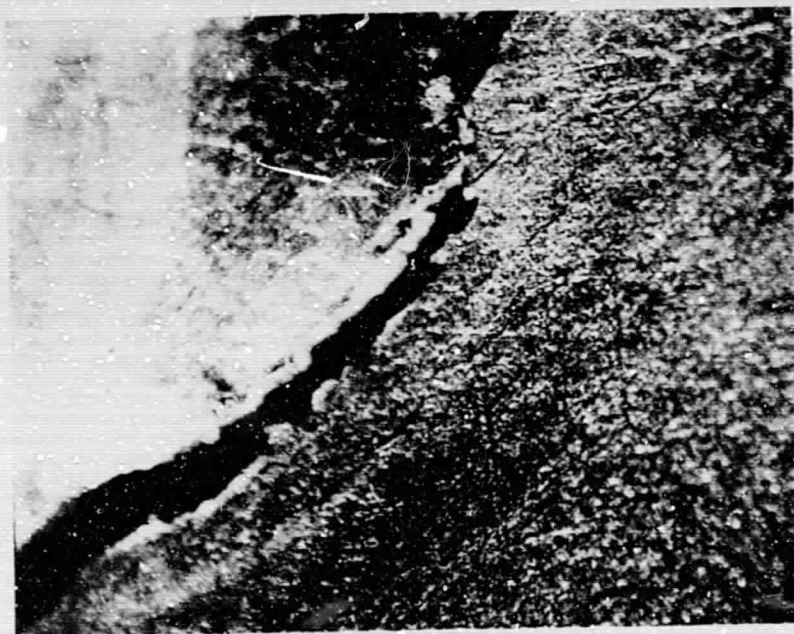
FIGURE 5. PHOTOMICROGRAPH OF BRITTLE FRACTURE

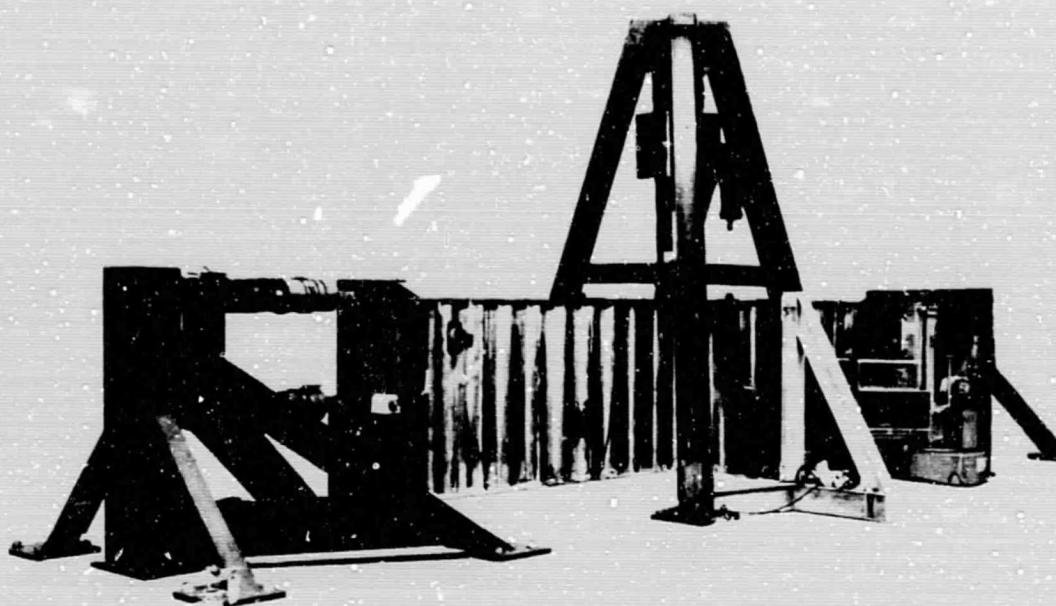
FIGURE 6. COMPLETE CROSSBEAM AND TESTING FIXTURE WITH ONLY ONE CYLINDER REMAINING

A method of repair was selected by joint action of the Propulsion and Vehicle Engineering and the Manufacturing Engineering Laboratories. The cable feed-through cylinders were removed by drilling a series of intersecting holes around each cylinder (Figs. 6 and 7.) Material for replacing the removed sections was obtained from test pieces of the 8-1-1 titanium alloy, formed to the sine wave configuration. This material was duplex annealed so that its metallurgical characteristics closely approximate those of the material in the cross-beam. The duplex annealing process is a heat treatment of 1003°K (1450° F) for 15 minutes followed by air cooling. This is in addition to the mill anneal.

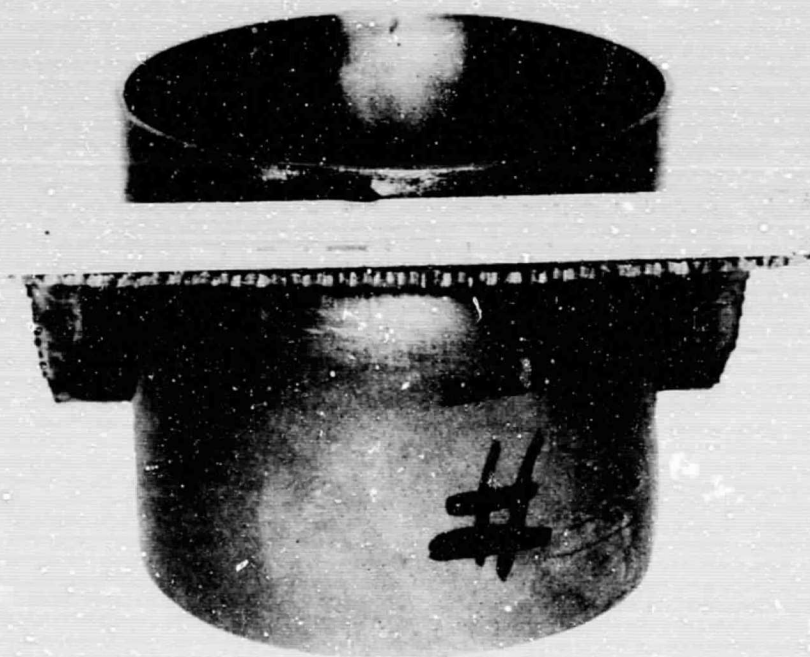
FIGURE 7. CABLE CYLINDER AS REMOVED FROM CROSSBEAM

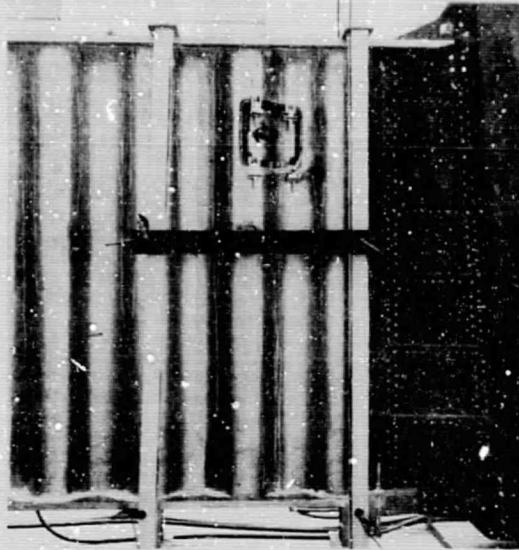
FIGURE 8. CROSSBEAM SECTION SHOWING JACKING SYSTEM USED TO ELIMINATE HORIZONTAL DEFORMATION DUE TO THE WEIGHT OF THE BEAM

Each titanium replacement panel was placed against its respective hole, and a line was scribed on the part indicating the shape of the hole. The four panels were milled along the scribe line allowing an 0.254 millimeter (0.010 in.) oversize. The parts were then hand fitted to the beam by grinding the edges with a hand grinder. Panel 1 was fitted to its hole with 0.508 millimeter (0.020 in.) clearance between each side of the part and the walls of the hole. Panels 2, 3 and 4 were hand fitted with 1.016 millimeter (0.040 in.) clearance on each side to achieve better penetration during welding. Prior to welding, a jacking system (Fig. 8) was fabricated to maintain horizontal alignment of the beam at the positions where the cylinders were removed.

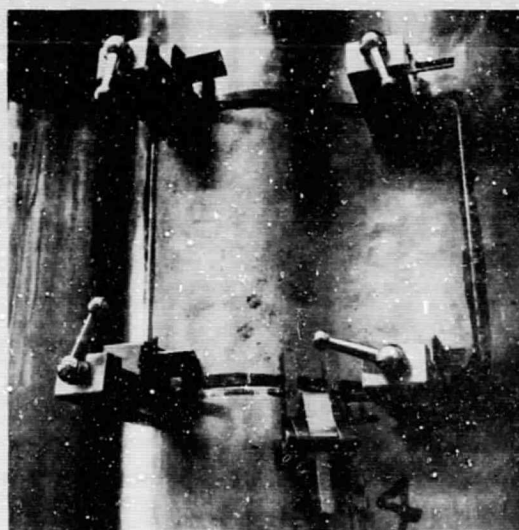
FIGURE 9. REPLACEMENT PART NUMBER 4, PRECISELY PLACED IN POSITION TO BE CLEANED AND WELDED

Upon completion of the machining processes, preparation began for welding the replacement parts into their respective positions. Strap clamps were utilized to ensure rigid placement of each part in position for welding as shown in Figure 9. The straps are cleaned in the same manner as the beam. The beam was prepared for welding by a combination of chemical and mechanical cleaning. It was hand cleaned with a 35 percent nitric acid and 5 percent hydrofluoric acid pickling solution and mechanically cleaned with a wire brush.

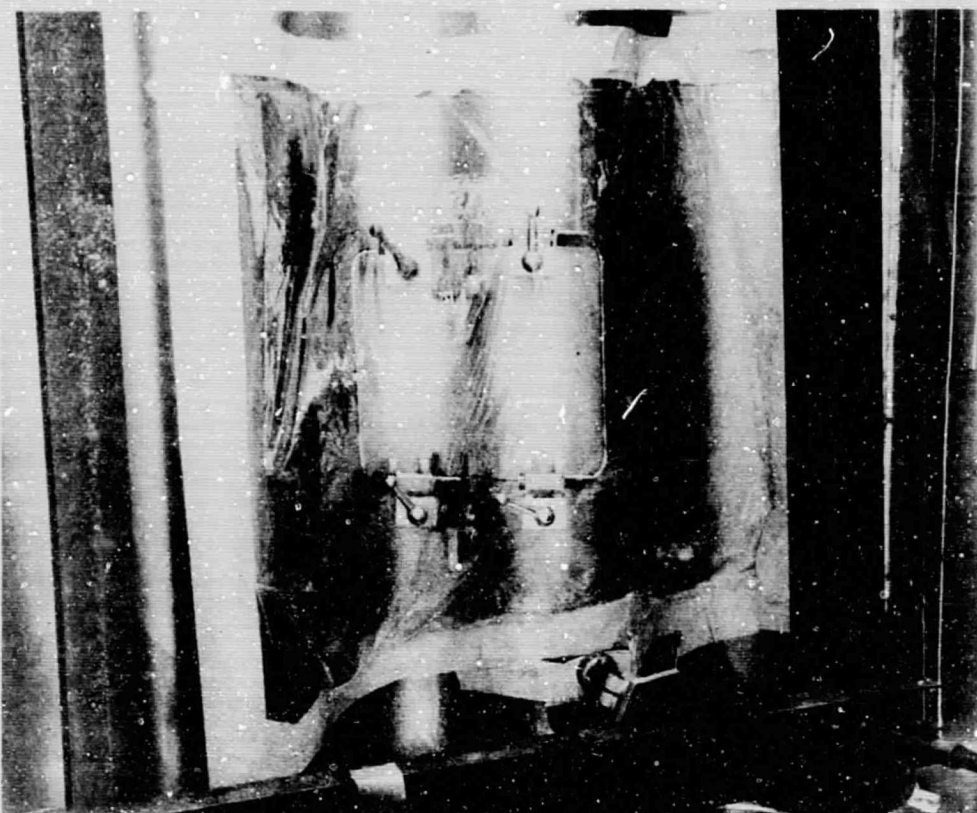
FIGURE 10. REPLACEMENT PANEL IN POSITION TO BE WELDED -
CLEANING AND BAGGING IS COMPLETE

After the parts were thoroughly cleaned and precisely fit to the beam with little or no mismatch, a plastic bag completely covering the area to be welded was taped on each side of the beam, as shown in Figure 10. The bag

was purged with argon for a period of one hour to remove all oxygen and hydrogen from the bagged area. A tungsten electrode and titanium filler rod was inserted through the bag to the welding area for use with TIG welding equipment. Welding in this manner is slow because of the limited area that can be welded without repositioning the electrode in the bag.

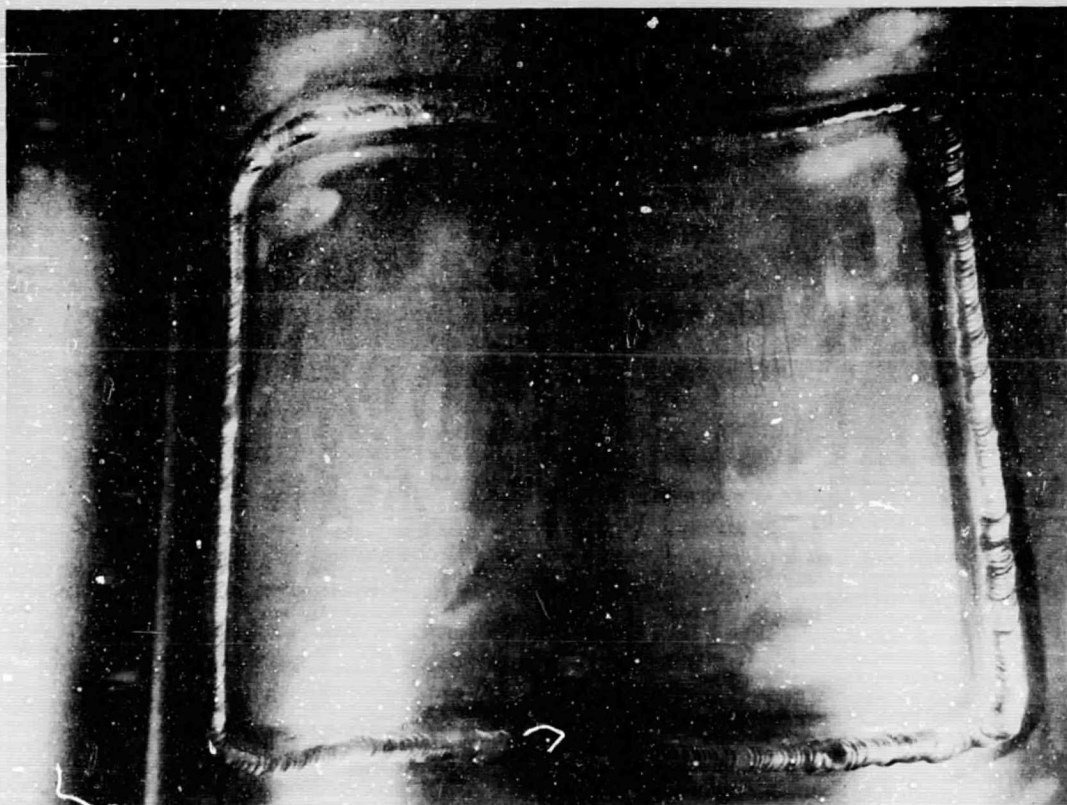
FIGURE 11. COMPLETELY WELDED REPAIR PANEL NUMBER 1

Figures 11 through 15 show the finished repair panels and filler welds.

The repair welds were completed with no apparent oxide contamination because the welding area was completely bagged with an inert gas-filled diaphragm. X-ray analysis indicates that all repair areas are acceptable. No unacceptable porosity or impurity appeared during the repair procedure; therefore, no repair weld required removal and replacement.

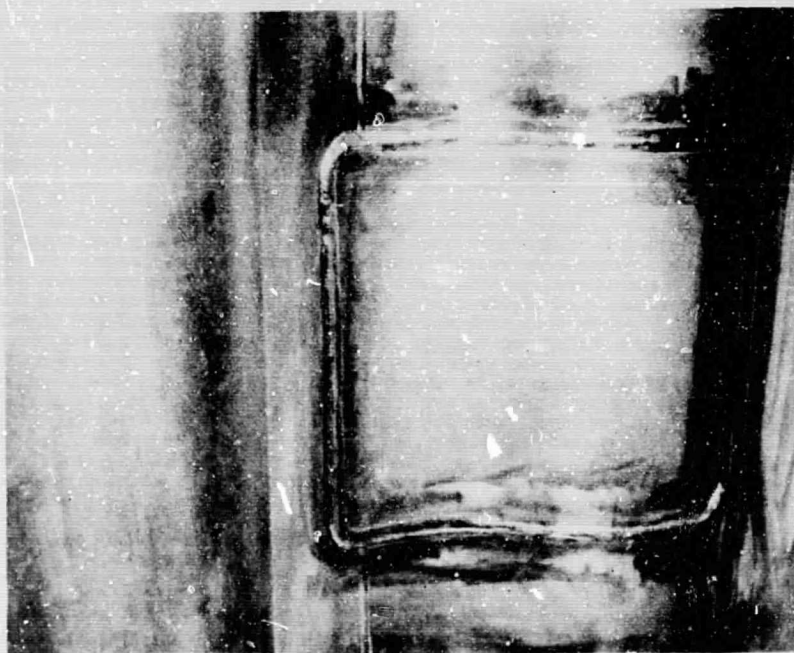
FIGURE 13. REPAIR PANEL NUMBER 3 WELDED INTO POSITION
